HOOP/COLUMN AND TETRAHEDRAL TRUSS  
ELECTROMAGNETIC TESTS

M. C. Bailey  
NASA Langley Research Center  
Hampton, Virginia

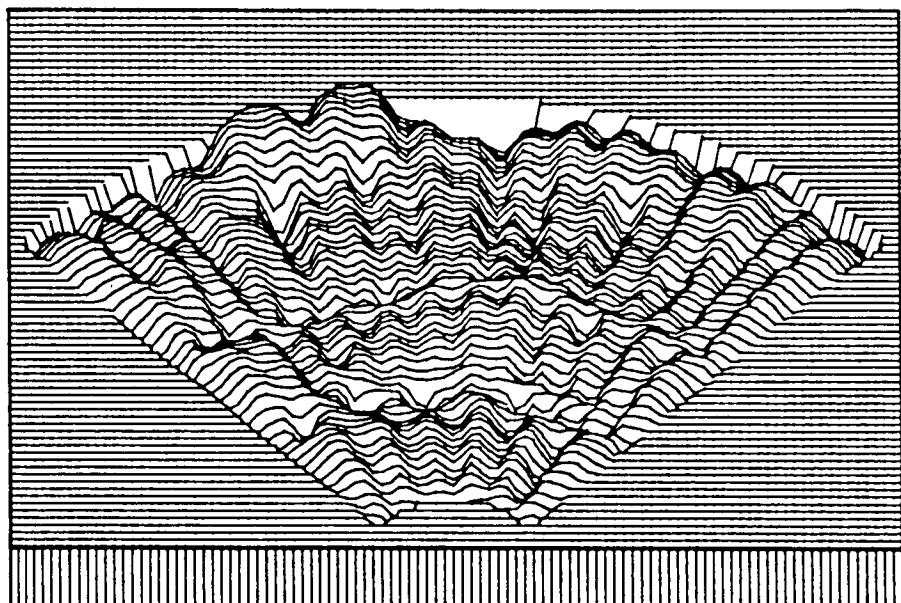
## SURFACE DISTORTION FOR HOOP/COLUMN REFLECTOR ANTENNA

The distortion of the hoop/column antenna was measured with a metric camera system at discrete target locations on the surface. This figure shows a plot of the deviation from a perfect paraboloidal surface for one quadrant of the hoop/column reflector. The height of the distortion is amplified on the plot in order to show the surface features.

(QUADRANT-4)  
(RMS = 0.167 CM)

MAXIMUM = +0.50 centimeter  
MINIMUM = -0.80 centimeter

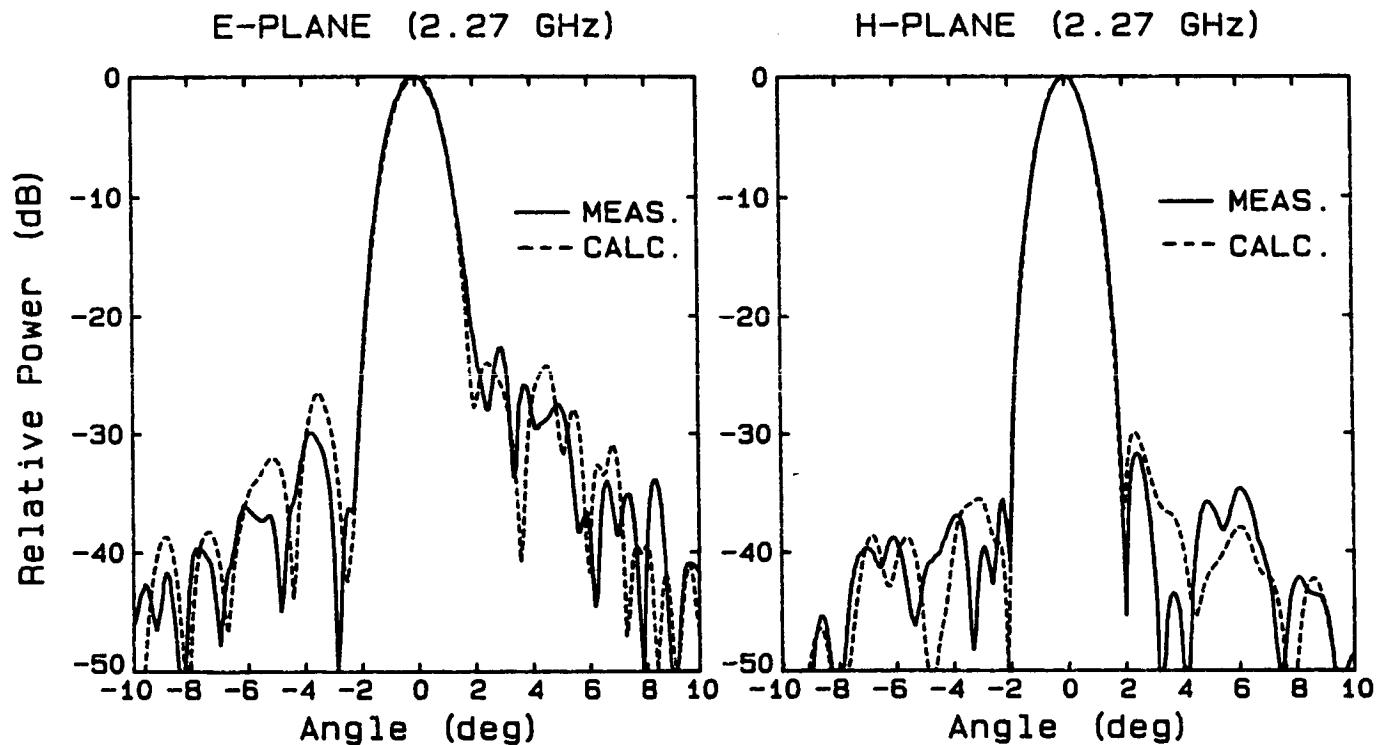
## 2.27-GHZ RADIATION PATTERNS FOR THE HOOP/COLUMN ANTENNA

The E-plane and H-plane radiation patterns are presented in this figure at 2.27 GHz. At this low frequency, the performance of the antenna is almost the same as a smooth surface.

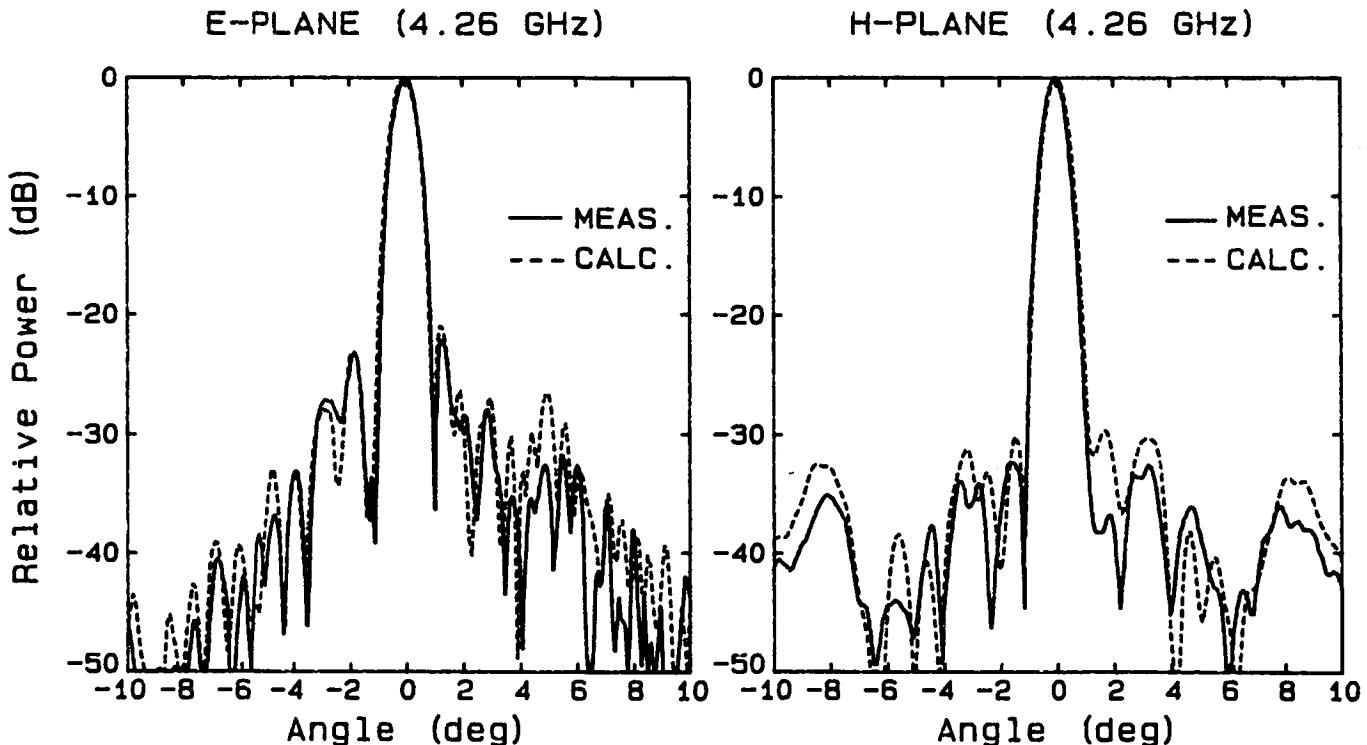
#### 4.26-GHZ RADIATION PATTERNS FOR THE HOOP/COLUMN ANTENNA

At 4.26 GHz, the H-plane radiation pattern shows the formation of two sidelobes symmetrically located about the main beam. These lobes are characteristic of periodic errors in an antenna, or referred to as "grating" lobes.

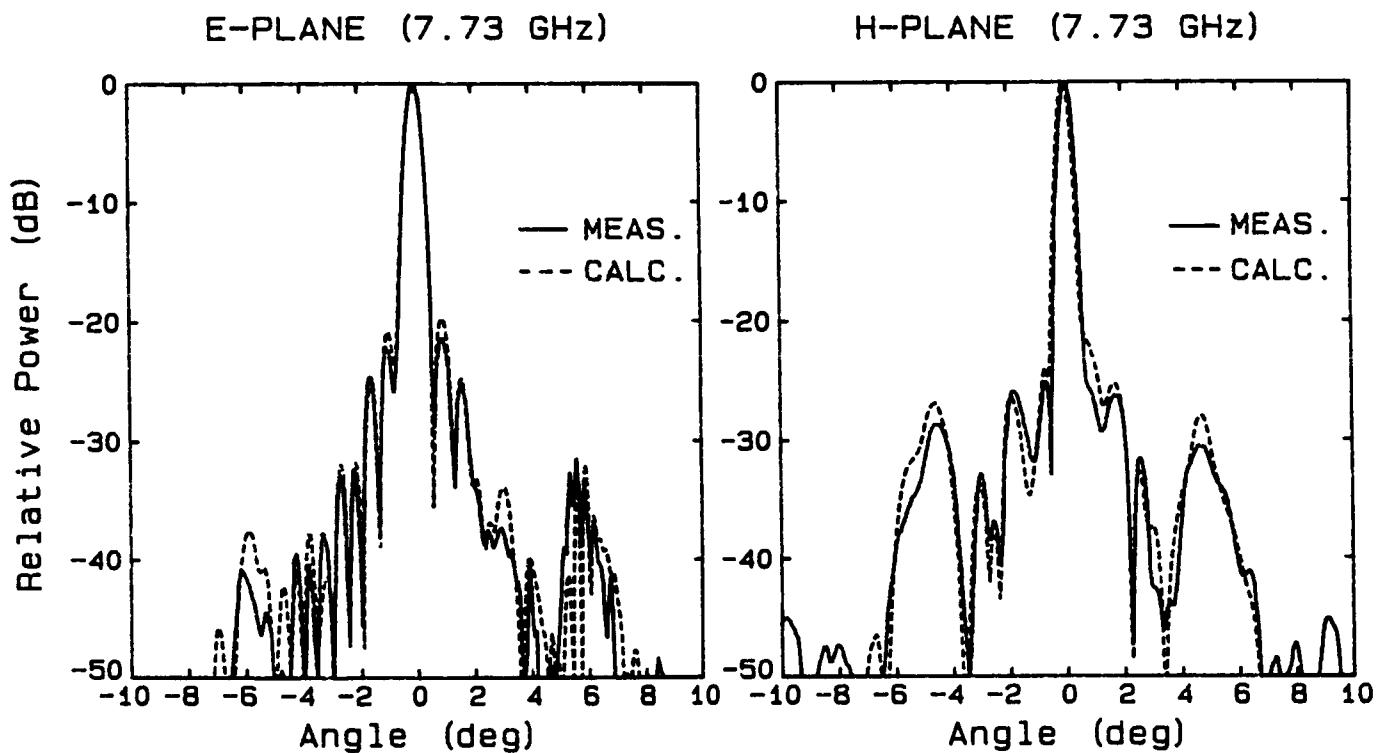
## 7.73-GHZ RADIATION PATTERNS FOR THE HOOP/COLUMN ANTENNA

At higher frequencies, these "grating" lobes increase in height and move closer to the main beam. In addition, the E-plane also shows sidelobes symmetrically located about the main beam and at a much lower level. One of these lobes (+6 degrees) in the E-plane shows some interference due to feed spillover onto the opposite quadrant of the reflector.

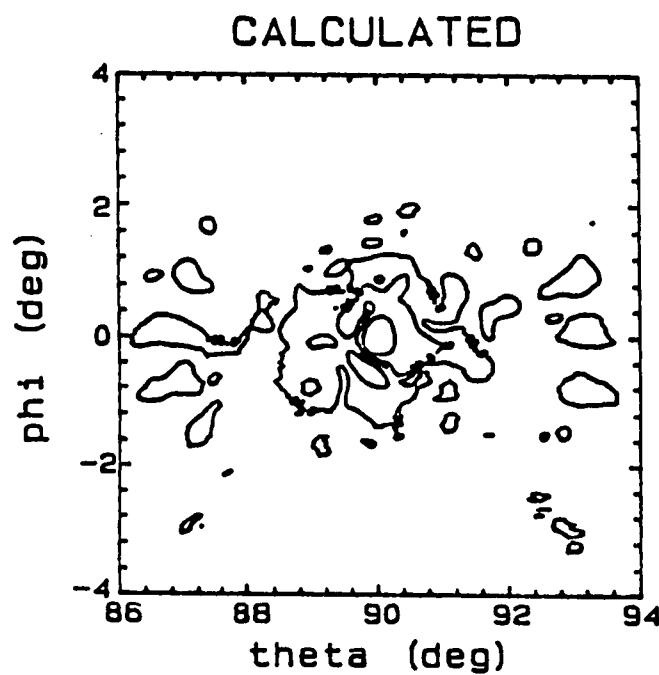
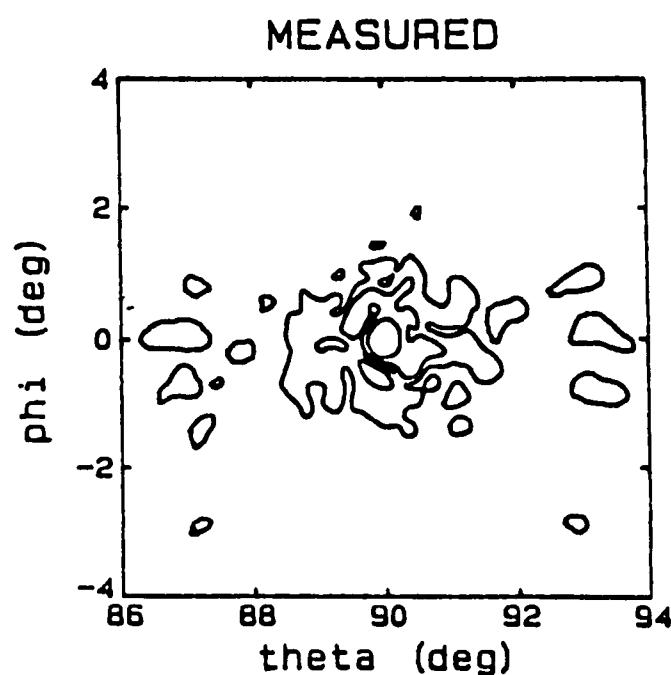
## 11.6-GHZ RADIATION PATTERNS FOR THE HOOP/COLUMN ANTENNA

The contour plots of the radiation patterns show the "grating" lobes are actually several lobes located in a circular arc about the main beam. This arrangement of the "grating" lobes is due to the ripple in the surface being periodic in the circumferential direction rather than in a linear direction as is characteristic of truly periodic grating lobes.

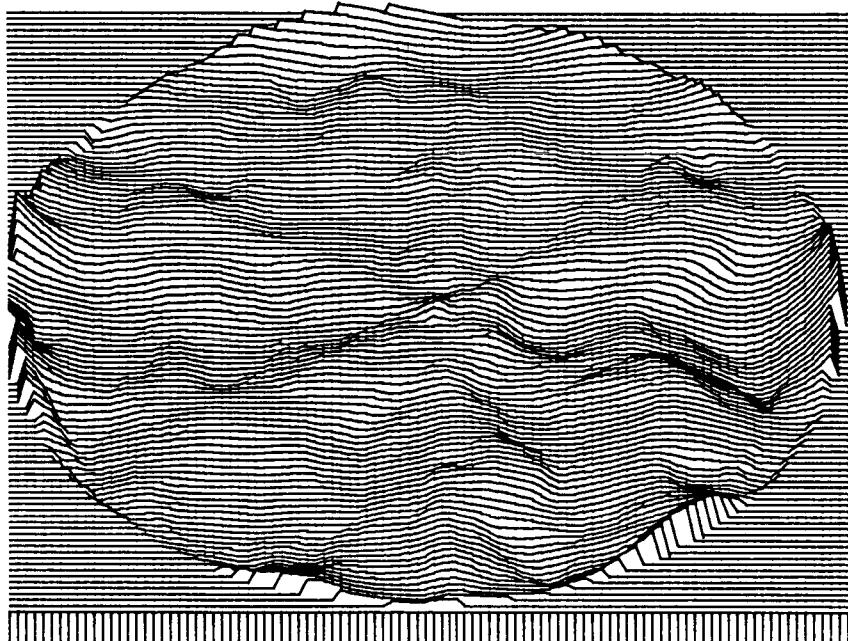
SURFACE DISTORTION FOR THE TETRAHEDRAL TRUSS REFLECTOR ANTENNA

The surface tie-points for the tetrahedral truss reflector were placed more randomly in order to avoid the periodic "pillowing" of the surface. This plot shows the deviation from a perfect paraboloidal surface with the height of the distortion also amplified on the plot.

(RMS = 0.091 CM)

MAXIMUM = +0.60 centimeter  
MINIMUM = -0.37 centimeter

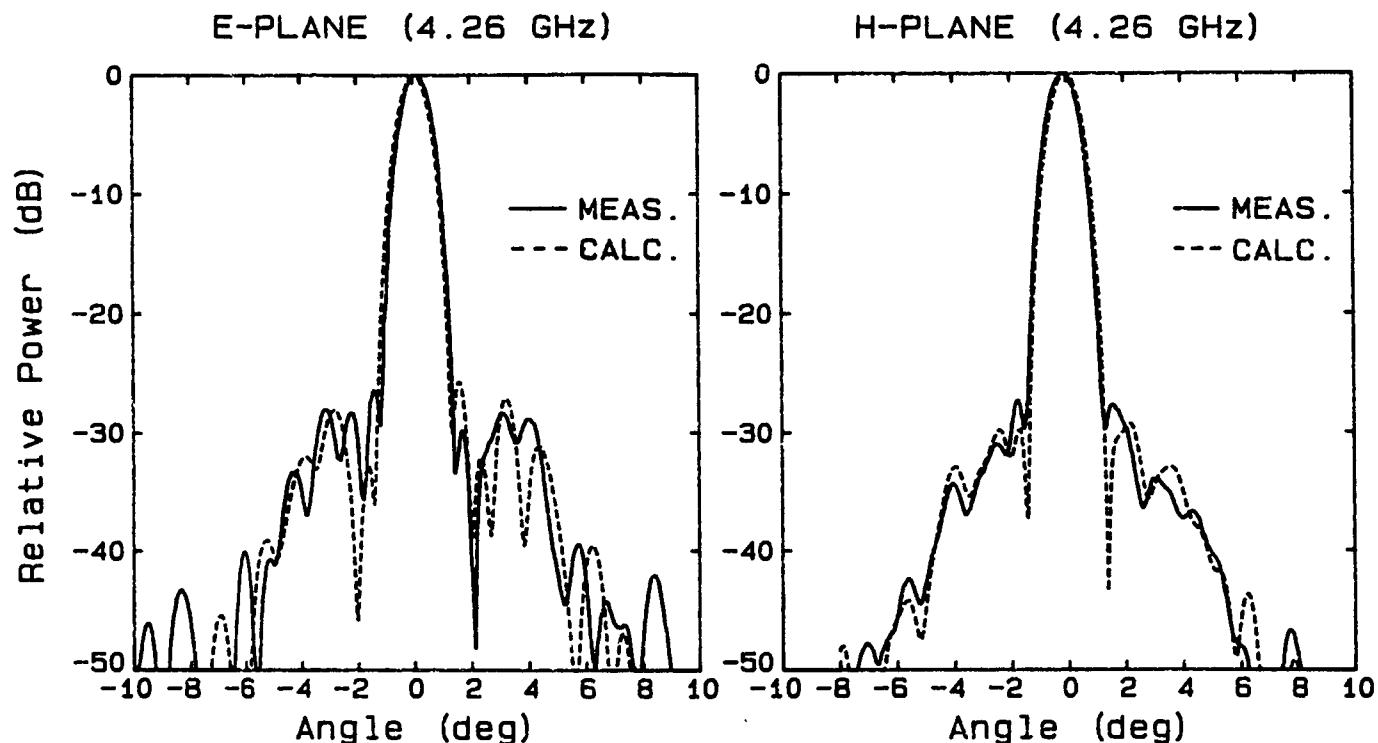
#### 4.26-GHZ RADIATION PATTERNS FOR THE TETRAHEDRAL TRUSS ANTENNA

Due to the randomizing of the surface tie-points, the radiation patterns for the tetrahedral truss do not have the "grating" lobes that were characteristic of the hoop/column antenna.

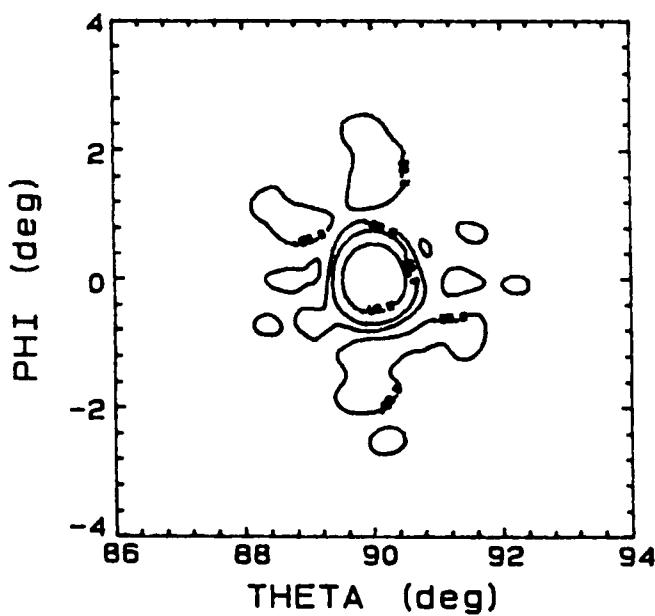
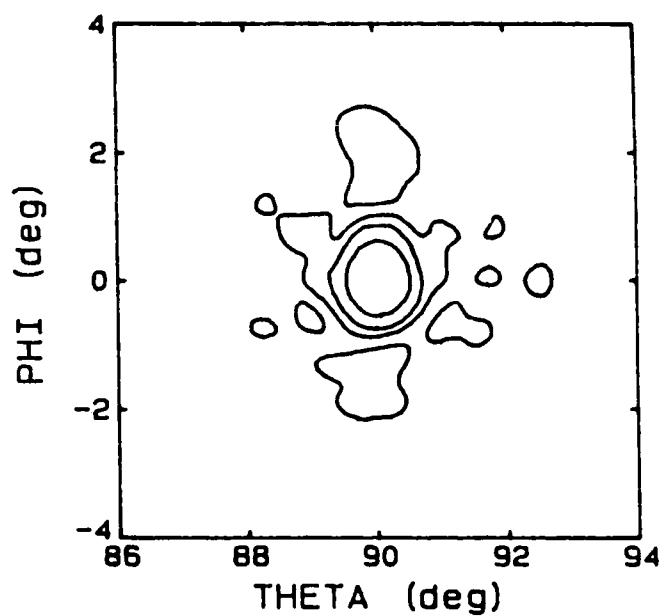
## 7.73-GHZ RADIATION PATTERNS FOR THE TETRAHEDRAL TRUSS ANTENNA

The contour radiation patterns at 7.73 GHz for the tetrahedral truss antenna do show symmetric lobes which appear to be trying to form in a six-fold symmetry about the main beam.

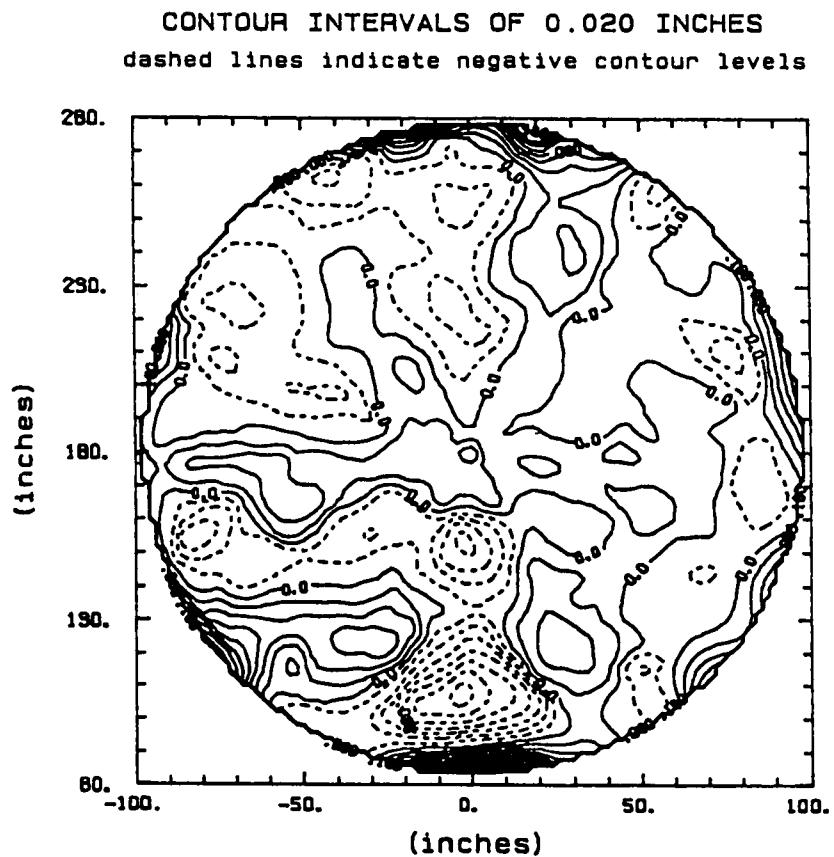
## SURFACE DISTORTION CONTOURS FOR THE TETRAHEDRAL TRUSS REFLECTOR

Close examination of the surface distortion contours for the tetrahedral truss antenna indicates that a six-fold symmetry does appear to exist in the surface, thus creating the sidelobe structure observed in the previous radiation patterns.
